Specific Purpose Survey  
Building 1 Settlement Investigation  
Report of Survey (2)  
For the River Club Condominium Owner's  
Association

The survey is located at Building #1 of the River Club Condominiums, 1600 NE Dixie Highway, Jensen Beach, Florida.

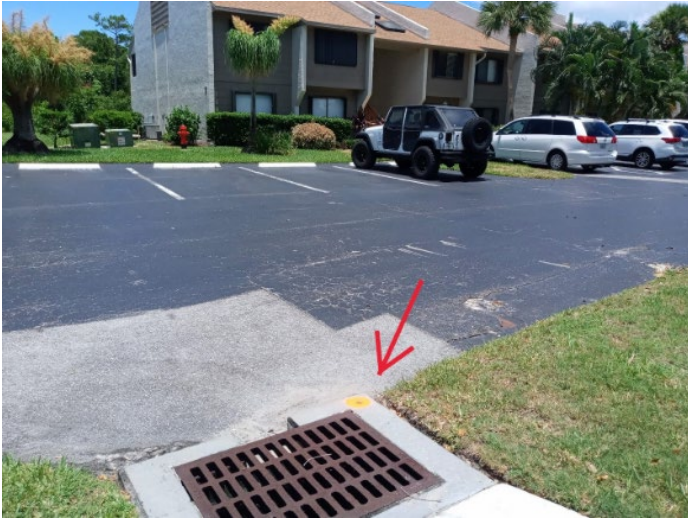
**Benchmark “A”**

Bowman set two permanent control points (“A” and “B”) on concrete storm structures for our base benchmarks. The marks are at a distance away from building to be free of any potential building settlement.
