# Building #1 Maintenance and Stabilization Rebuttal to Ken Kusen Email

## 2015 Report

Study that was undertaken by Universal Engineering Sciences dated March 18, 2015, as contracted by RCMC. Here are some of the findings.

In 2019 the issue was brought up about bank stabilization and another engineer was directed by RCMC to do a study and a report. This time it was with MCR Professional Engineering.

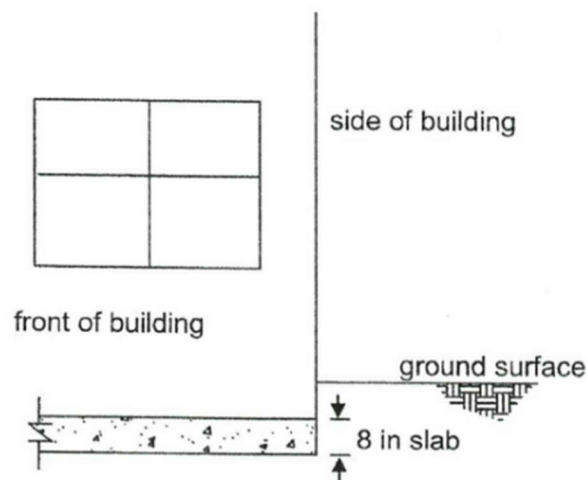
Figure 2. (not to scale)

The existing foundation was explored at location TP-2 southeast corner of Building No. 1. No footing was found, it was discovered that a slab-on-grade approximately 8 inches thick supports the building. The dimensions are shown below in Figure 2.

The loose soil conditions found in the test borings at locations B-3, B-4, B-5, and B-6 adjacent to Building No.1 appears to be a contributing factor to the building settlement. Uneven settlement likely resulted from different support conditions. Therefore, we recommend the use of a deep foundation system to transfer foundation loads to a stable bearing layer beneath the loose soils. Deep foundations may consist of helical piers, pin piles, micro-piles or similar elements designed by a structural engineer. Such a foundation system should be designed within the settlement tolerances of the structure, and installed by a contractor experienced with pile foundation construction.

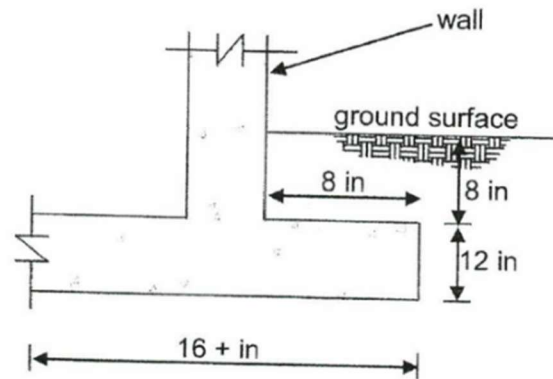
Figure 1. (not to scale)

The existing footing was explored at location TP-1 to measure the thickness and width of the footing at Building No. 14. The footing is 12 inches thick and about 16+ inches in width. The dimensions are show below in Figure 1.

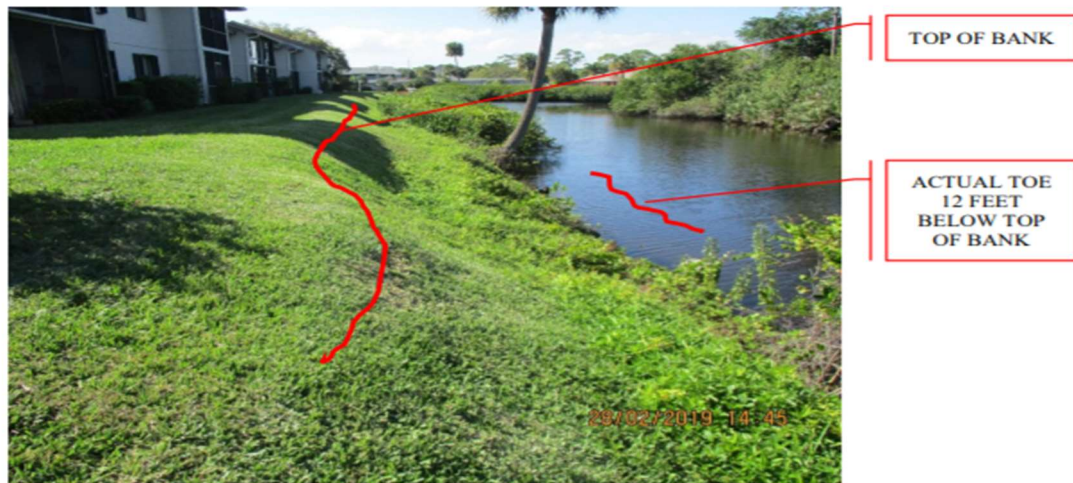
Photo 1 View looking West

- At some point rip rap was installed along the shoreline
- See pictures of the complete failure

East End of Building #1.

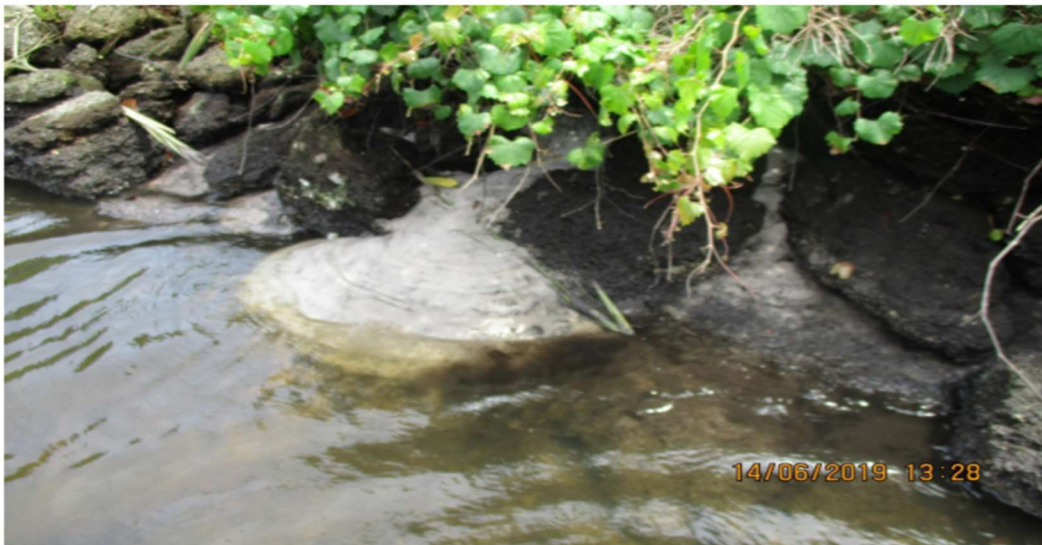
Photo 2 - Sand at toe of rip rap.

This indicates erosion under the rip-rap from the embankment. This observation was typical along the toe of the rip rap. The embankment continues to slope into the water an additional 10 feet horizontal and 3 foot vertical.

.A vinyl, upland retaining wall with an exposed height of 3 feet, with 5 foot embedment is recommended. (See attached repair sketch option A). An optional approach is to install erosion control fabric on the slope, install additional rip-rap as refurbishment and stabilization, and then backfill and sod the embankment back to the approximate original slope. A sketch of this alternative method is annotated as option B.

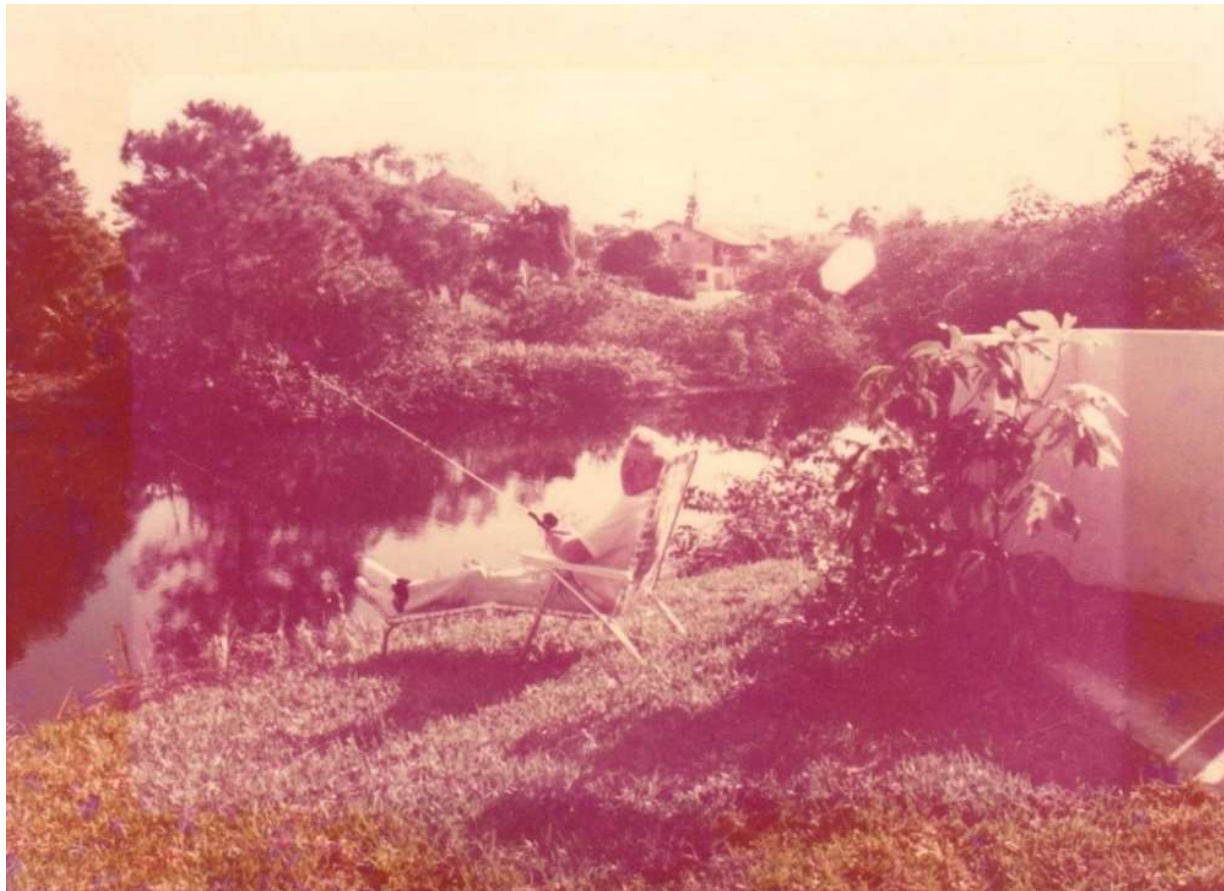
Here is a picture that we have from ~ 1980 which shows Mr. Swanson in a lounge chair at the end of the wall that is still there. If you were to try and lay in a chair in this location today, you would be laying at a 45-degree angle with your feet touching the water. As it is commented in the email please come back behind the building and compare this picture to what you can see for yourself.

It is not that the waterline has moved closer to the building it is the fact that the top of slope has eroded and the breakover point of top of slope has moved closer to the building. So
